Brush Seal Bristle Flexure and Hard-Rub Characteristics

Robert C. Hendricks, Julie A. Carlile,
and Anita D. Liang
Lewis Research Center
Cleveland, Ohio

Prepared for the
Seals Workshop
sponsored by the NASA Lewis Research Center
Cleveland, Ohio, August 5–6, 1992

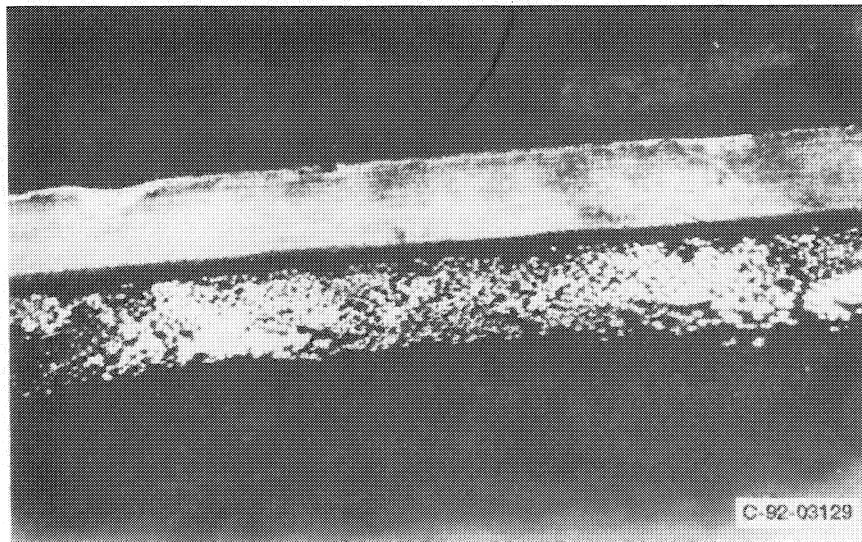
The 38.1-mm (1.5-in.) diameter brush seal (fig. 4) was damaged in a previous series of tests related to reference 2. The damaged section, although quite small and having a "chewed" appearance, increased seal leakage. The seal could no longer be used for leakage tests but was adequate for the tests herein.

Figure 4.—Brush seal prior to tests (270° mark).

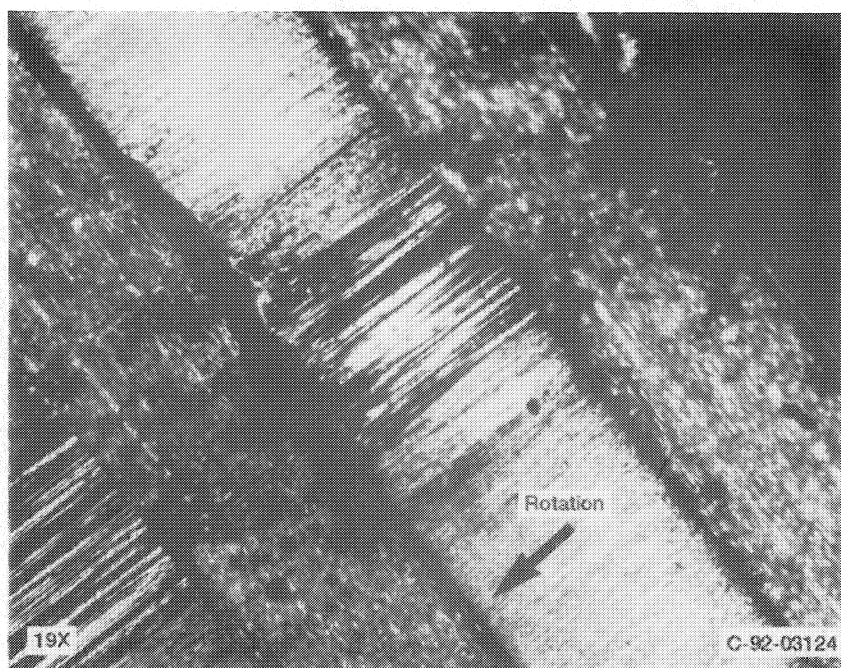
Optical inspection of the grooves cut by the brush into the stainless steel rotor (test 1) showed that the cut converged from the leading edge to the trailing edge of the land as the wires (bristles) crossed the rotor (fig. 5). Wire grooves were clear cut and debris was evident, as is better shown in the enlargement (fig. 6).

Width at inlet	1.52 (0.06)
Width at center	1.3 (0.051)
Width at outlet	1.27 (0.05)

Figure 5.—Rotor surface after test 1. (Arrow shows direction of rotation.)

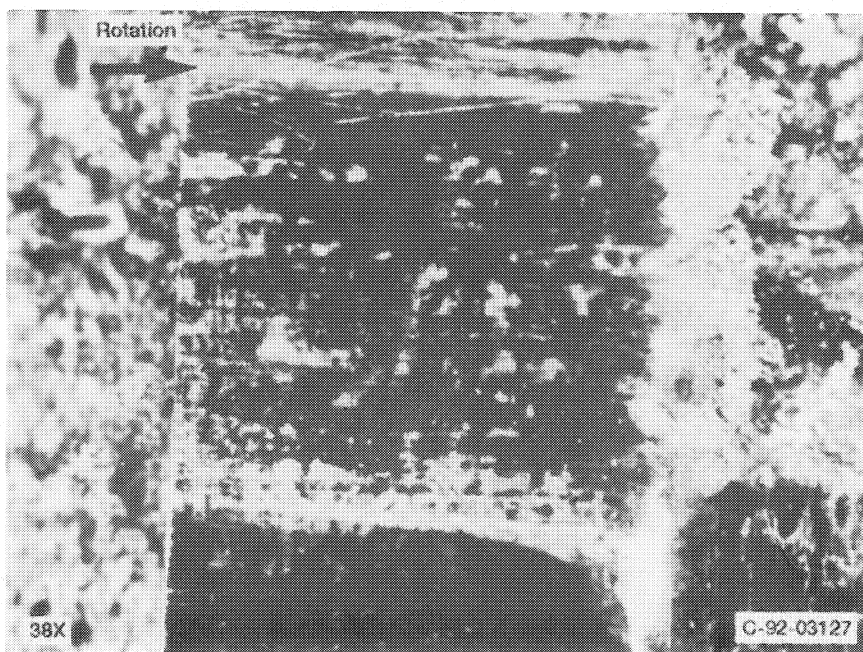
Figure 6.—Rotor land and groove after test 1.

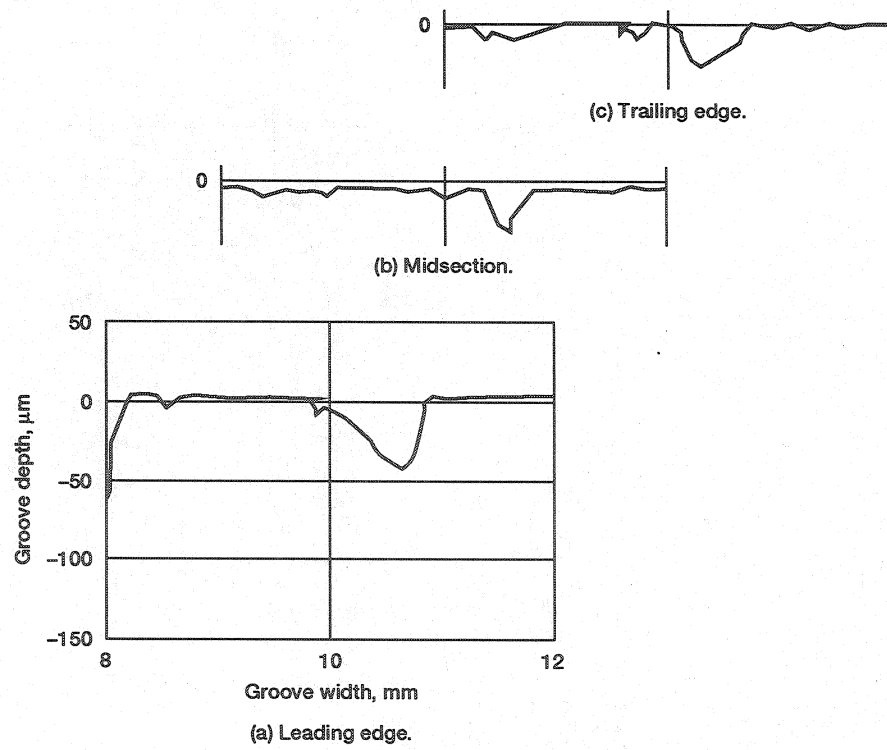
In order to corroborate the optical results, profilometer results for a typical tooth of the 40-tooth rotor were taken. Wear area and groove depth estimates are provided in table III. Values for the extent of the groove in millimeters (inches) are shown in figures 7 to 9 at a resolution of 0.02 mm/division.

The first profile, labeled "leading edge," was taken within 0.10 mm (0.004 in.) of the leading edge and shows a broad damage region with deep grooving for test 2 (fig. 8(a)) and test 3 (fig. 9(a)) but a minor amount of material damage for test 1 (fig. 7(a)). The material buildup adjacent to the groove of test 3 probably occurred during rotor-fence rub. The second profile, labeled "mid section," was taken midway between the tooth leading and trailing edges. The damage of test 2 (fig. 8(b)) and test 3 (fig. 9(b)) was severe, and a twofold cut has developed in the rotor during test 2. Again moderate damaged was noted for test 1 (fig. 7(b)). The third profile, labeled "trailing edge," was taken within 5 percent of the trailing edge. The grooving seen in the midsection profile carried through with perhaps some sharpness of the features near the trailing edge (figs. 7(c), 8(c), and 9(c) for tests 1, 2, and 3, respectively).

Figure 7.—Profilometer traces for 40-tooth rotor (test 1).

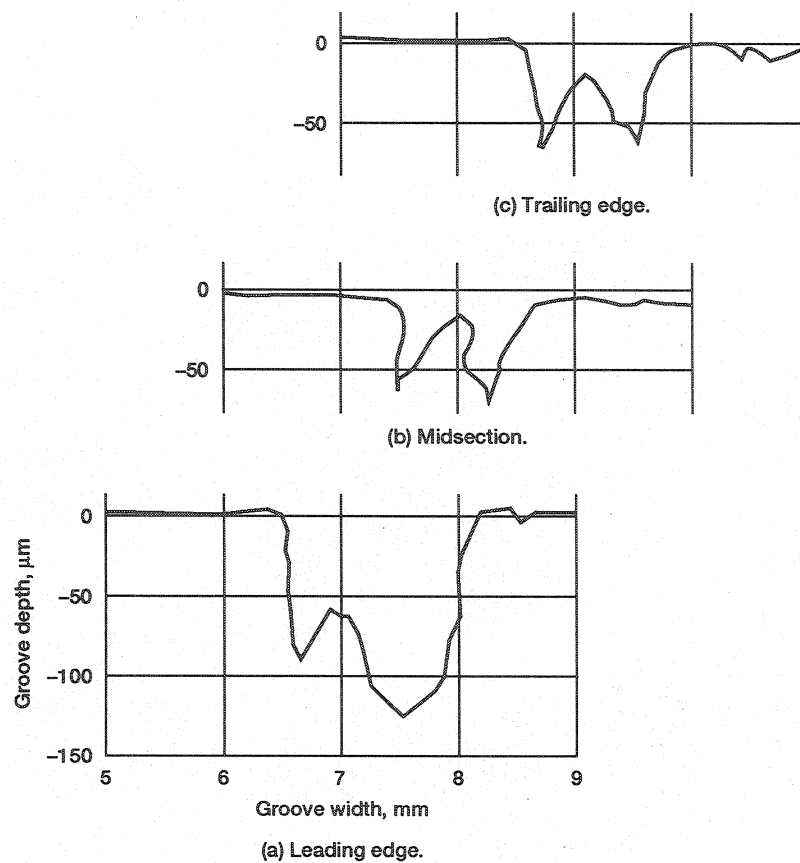
Figure 8.—Profilometer traces for 40-tooth rotor (test 2).

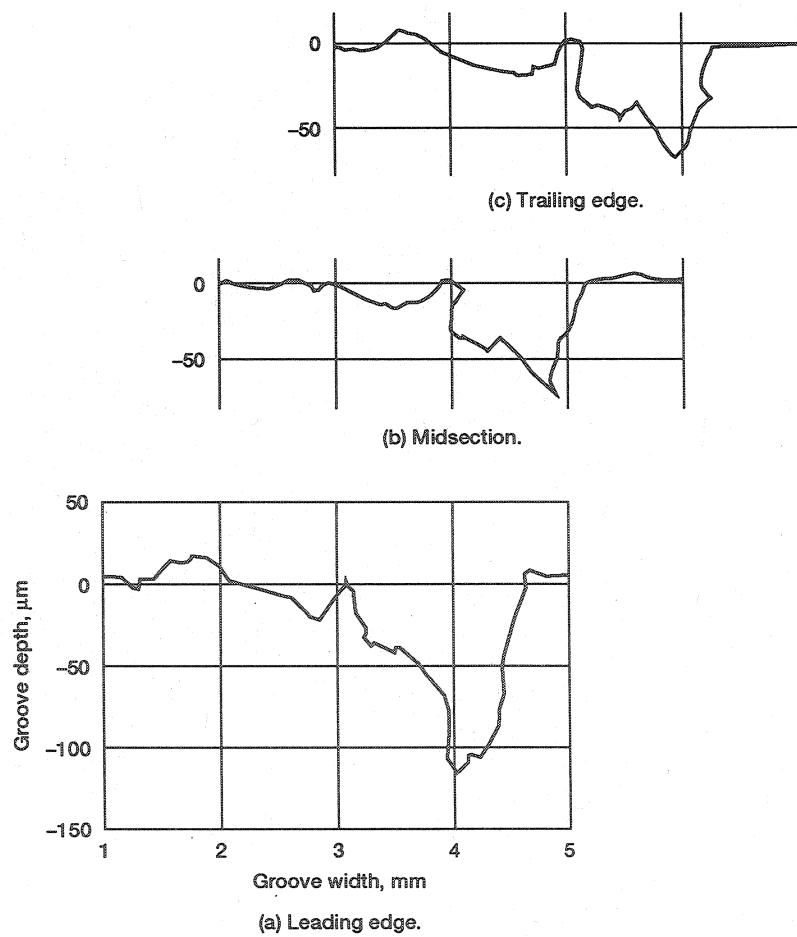
Figure 9.—Profilometer traces for 40-tooth rotor (test 3).

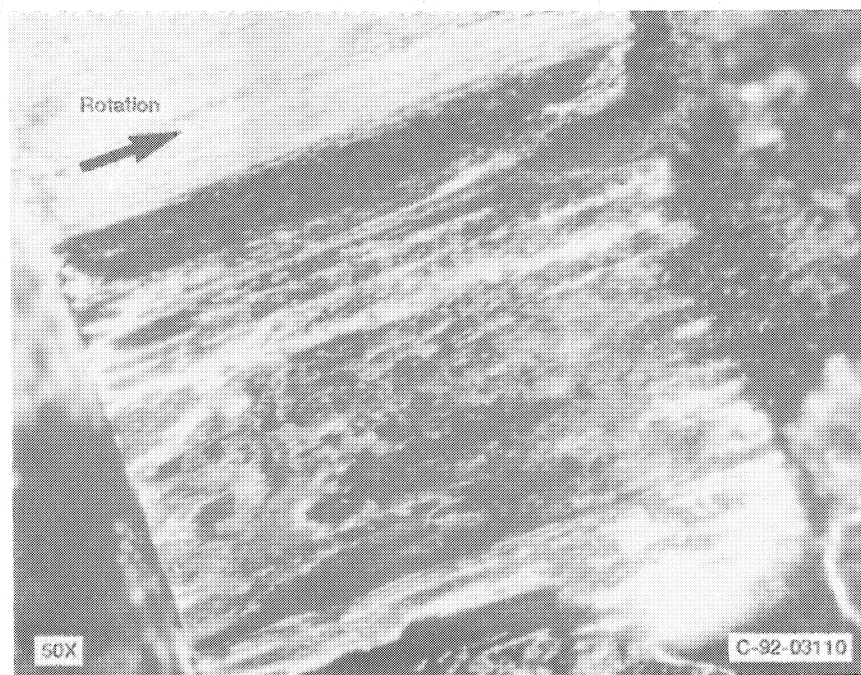
The brush bristle impact at the leading edge left material deposits that were magnetic (i.e., from the rotor) and rust color (probably Fe_3O_4) with a spongelike (or cauliflower) appearance (fig. 10); these deposits are readily seen at higher magnification (80X) in figure 11. Debris was generated by surface machining grooves, "whipping" of the leading edge, burnishing, and sharp trailing edges. The deposited materials were fine, porous, "greasy" to the fingers, and readily removed from the rotor; removal from the bristles was not straightforward. Standard degreasing cleaned but not thoroughly, and ultrasonic cleaning was not attempted. The reasoning was to see if these deposits would inhibit the responsive character of the bristles. The debris can affect both the response and the leakage, but neither effect was observed in these tests. Further work here is warranted.

Figure 10.—Rotor land with debris and rub scars (test 2).

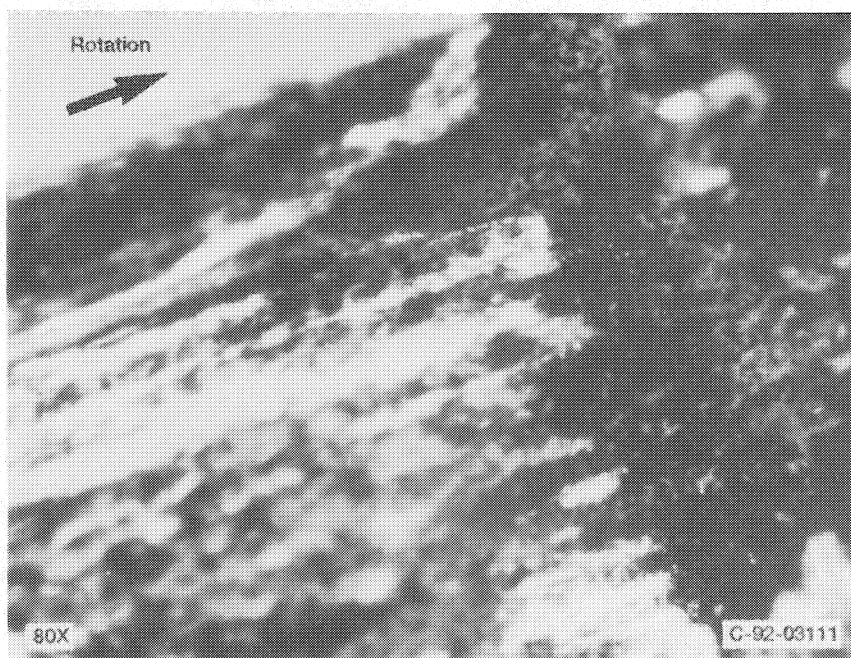
These deposits also indicate rapid wear-in with a long oxidation period for the "machined out" material. The materials deposited on the groove wall at the land leading edge (fig. 11) and on the groove wall at the land trailing edge (fig. 12) had little or no structure; the defraction spectra were peakless.

Figure 11.—Rotor leading-edge debris formation (test 2).

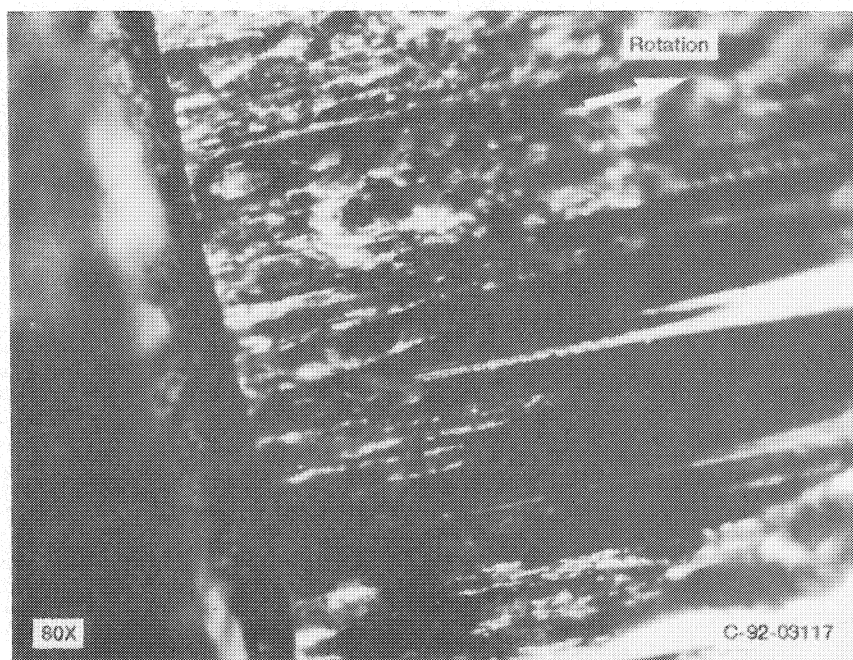
Figure 12.—Rotor trailing-edge surface grooving and debris (test 3).

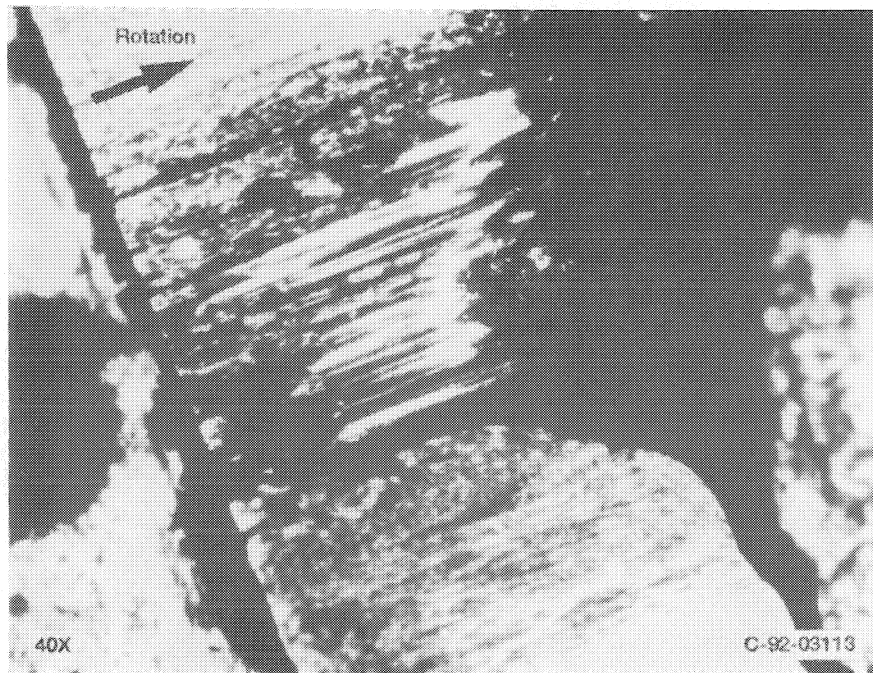
Stainless steel work hardens so that the cut grooves were probably harder than the parent stainless steel and would wear the annealed Haynes 25 bristles. The smooth grooves, the hot spots, and the hot streaking may indicate that a thin layer of stainless steel flowed plastically as it was machined out (figs. 13 and 14). Because of the incursive impact of the toothed rotor and the heated interface, the

Figure 13.—Rotor leading edge, surface machining, and hot spots (test 3).

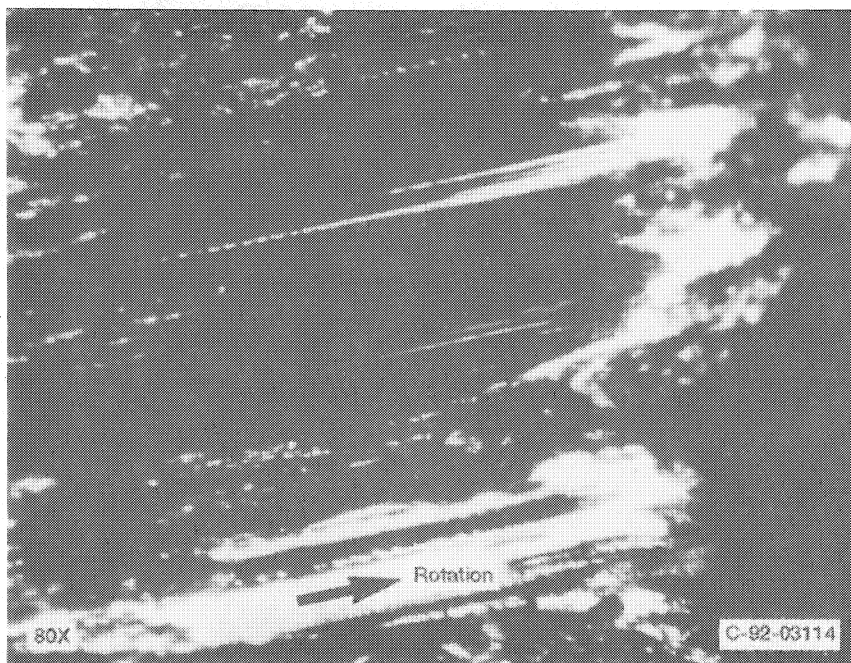
Figure 14.—Rotor land hot streaks, hot spots, and surface machining (test 3).

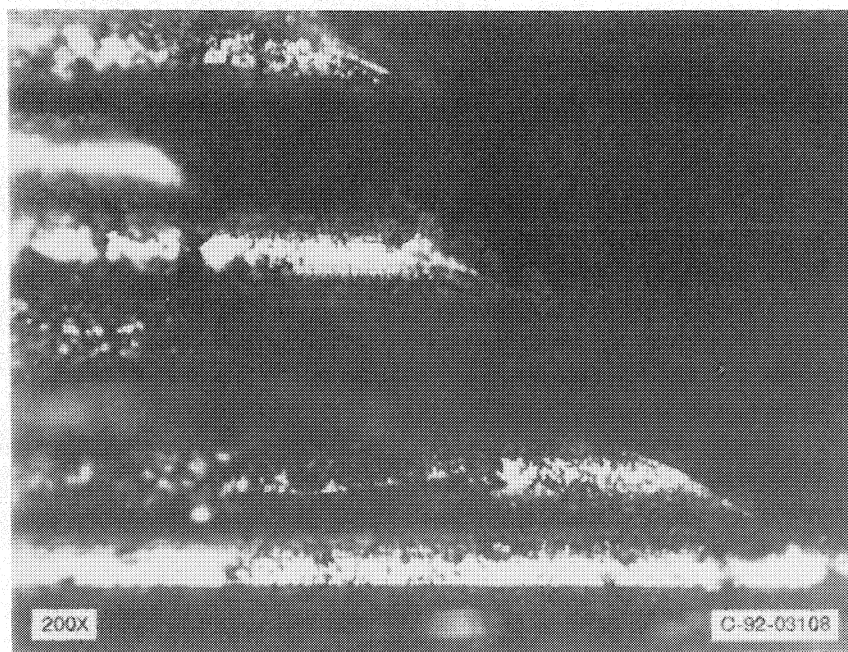
Haynes 25 bristles could lose strength, erode, fracture, or pull out as massive debris. But no pullouts or massive debris was found after any of the three tests. At higher magnification (200X) the tips still appear intact without fracture, but wear is evident and oxidation debris appears to be well adhered to the surface (fig. 15). As further evidence of the bristle wear an examination of the bristle tip surface revealed tip grooving (fig. 16), and the severe impacting on the bristles is shown by erratic wear notches on the bristle surface (fig. 17).

Figure 15.—Brush bristle tips with debris (test 1).

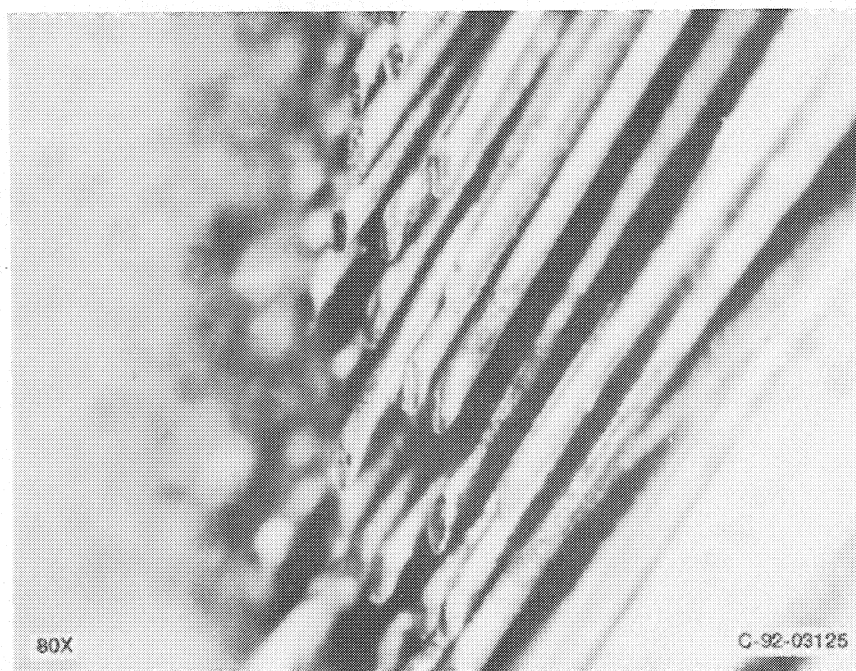
Figure 16.—Brush bristle tip wear patterns (test 2).

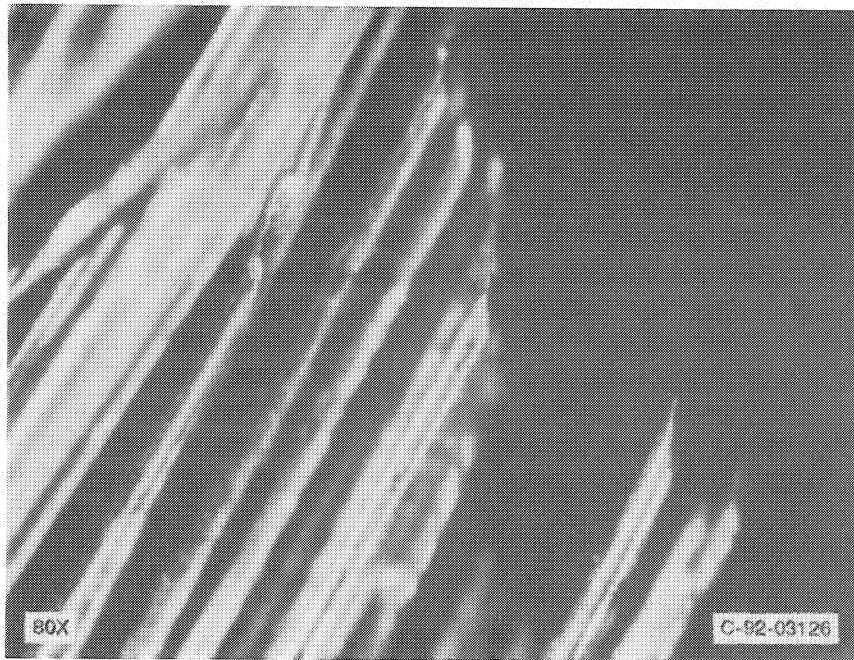
Figure 17.—Brush bristle tips and damage (test 1).

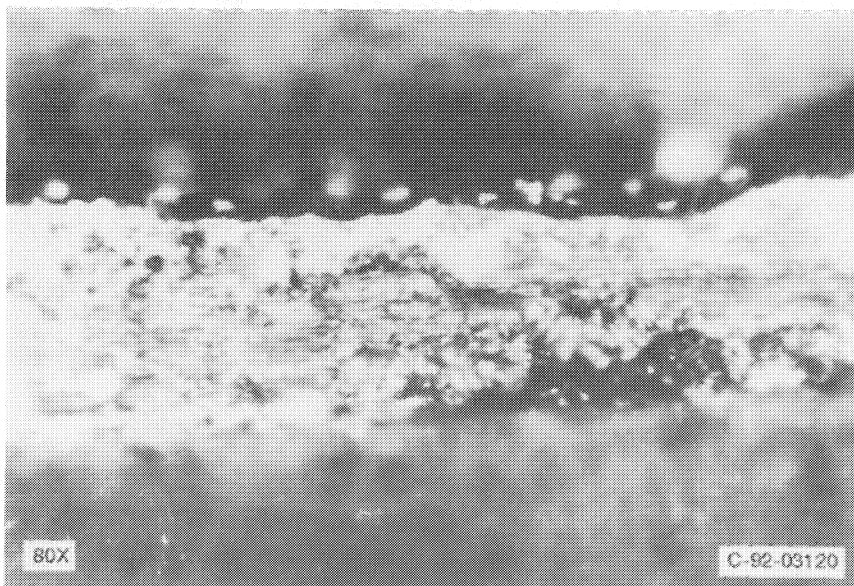
The trailing edge of the land was "cut" clean by the brush in all three tests (fig. 18) in stark contrast to the erratic leading-edge surface, which was whipped by the bristles (fig. 19). Of interest is the contrast between the land surface cuts. Test 1 surface cuts were a simple wear scar; those of tests 2 and 3 were multiple grooves with complex surfaces and burnishing (fig. 20). The most rotor damage appeared from test 2 and the most brush damage from test 3, where the rotor was set eccentric.

Figure 18.—Rotor trailing edge (test 3).

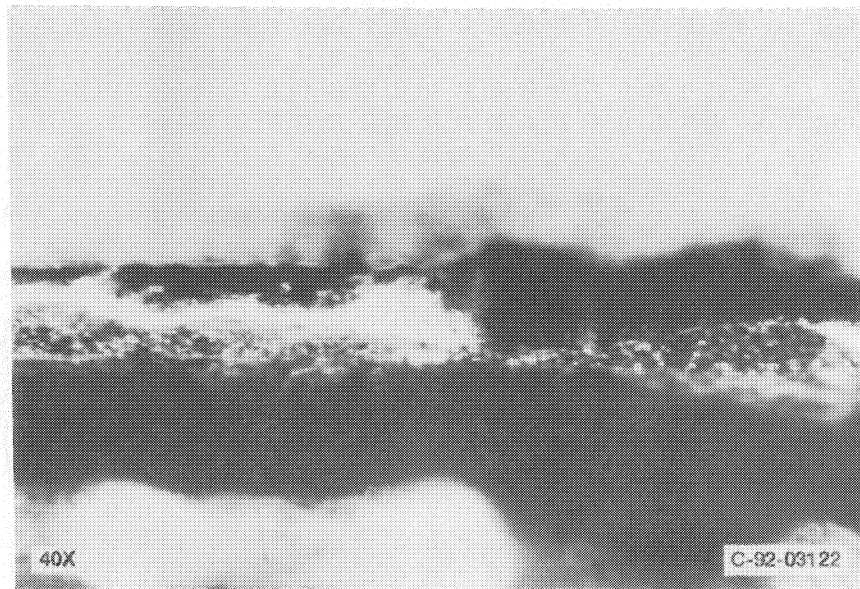
Figure 19.—Rotor leading edge (test 2).

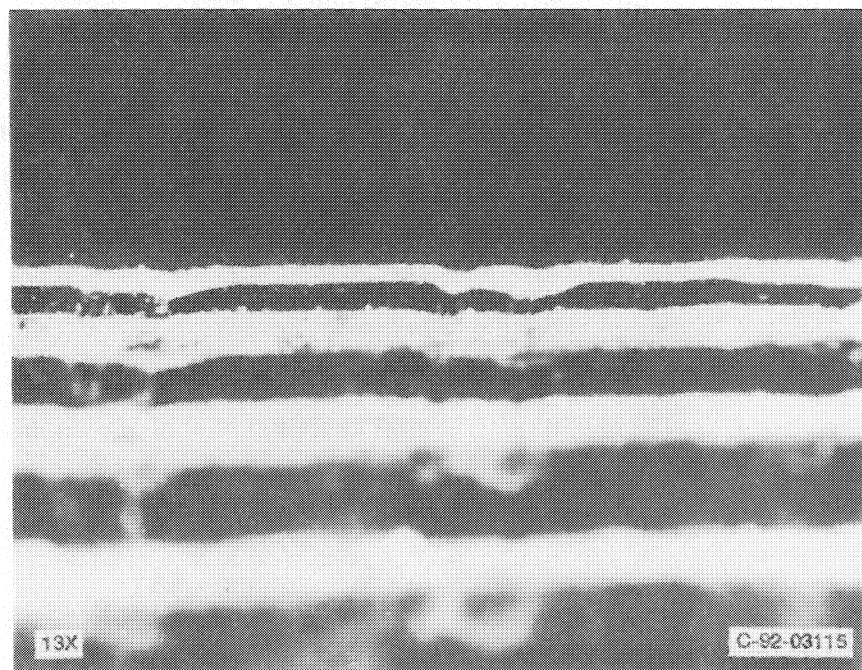
Figure 20.—Rotor trailing edge (tests 1, 2, and 3).

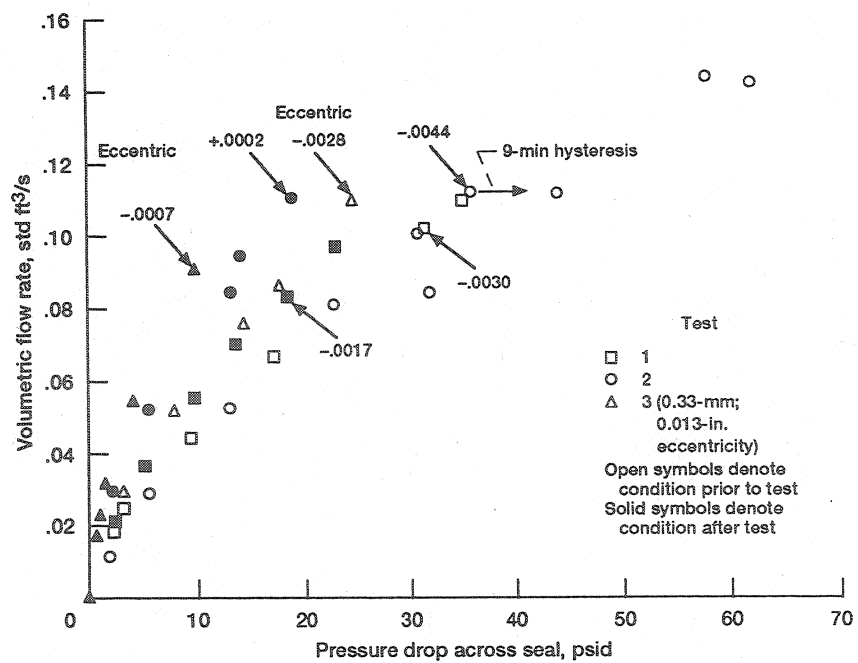
Leakage is characterized in figure 21 in terms of volumetric flow rate as a function of pressure drop across the brush seal before and after each of the three tests. Both pretest and post-test results are provided in the same figure. Because this brush seal was damaged (see APPARATUS section), absolute leakage measurements would require weighing, but the relative leakage should be accurate. The interference fits for the brush seal leakage data for pretests 1 and 2 were nearly the same, resulting in corresponding leakages. While taking data it was found that the brush would stiffen and the pressure drops would increase. Data points illustrating hysteresis (typical in brush seals) are shown. After correcting the post-test 2 data for clearance, these test results agreed with those of post-test 1.

Figure 21.—Pre- and posttest leakage results for smooth rotor.

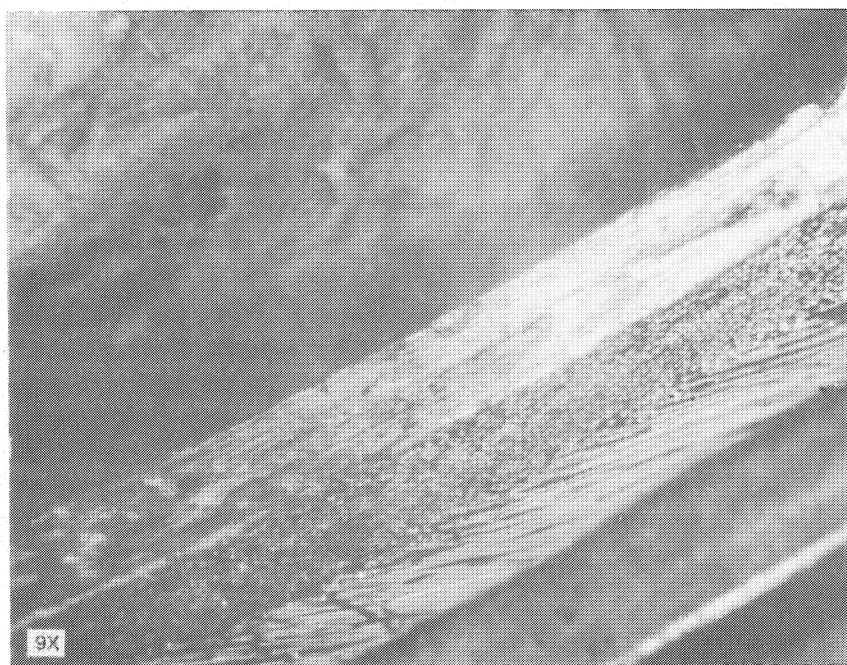
Setting the rotor eccentric in test 3 proved a major problem in cross correlating the leakage results. The estimated initial static eccentricity for the smooth rotor was less than 0.15 mm (0.006 in.), and the smooth rotor and the 40-tooth rotor were assumed to be interchangeable at the same spindle loading. However, the rotor rubbed the fence (backing washer) slightly, requiring an initial static eccentricity of 0.36 mm (0.014 in.) and implying a difference in spindle loading. The rotor was reset to an estimated eccentricity of less than 0.025 mm (0.010 in.). Post-test photographs indicated that the dynamic eccentricity was <0.10 mm (<0.004 in.) and clearly illustrated the fence rub (fig. 22).

Figure 22.—Fence damage sustained during test 3.
